# Engine Materials Characterization and Damage Monitoring by Using X-Ray Technologies

George Y. Baaklini

(NASA-TP-3328) ENGINE MATERIALS  
CHARACTERIZATION AND DAMAGE  
MONITORING BY USING X RAY  
TECHNOLOGIES (NASA) 103 p

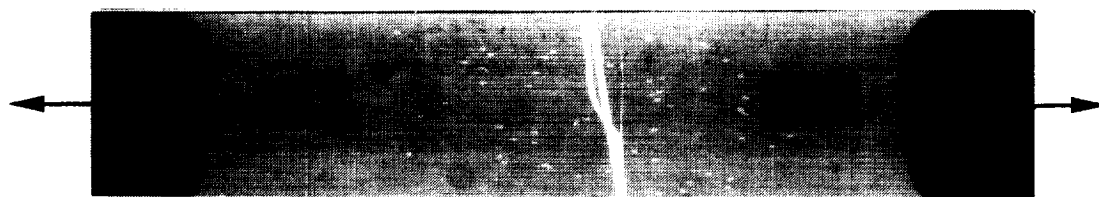
Figure 6.7.—Microfocus radiographs of SIC/RBSN specimens after failure.

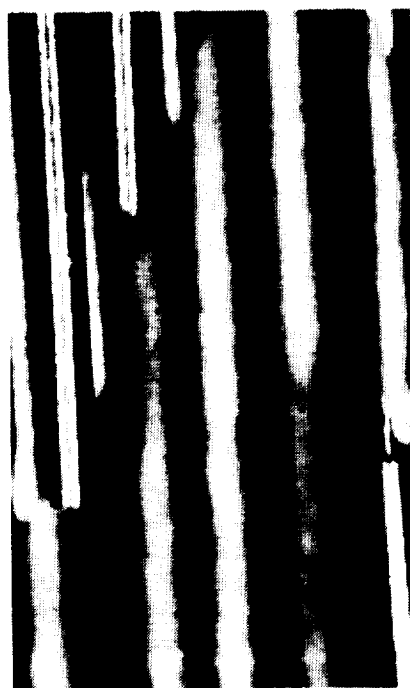
Figure 6.19.—Overprocessed eight-ply SiC/RBSN composite.

(a) 1200 °C in  $N_2$  for 40 hr.

Figures 6.18 to 6.20 display different failure mechanisms between an optimized (fig. 6.18) and an overprocessed (fig. 6.19) composite. In the optimized case, fibers bridged the cracks and prevented a catastrophic failure. In the overprocessed case, random fiber pullout is evident throughout the gauge length. Some fibers were broken even before testing by overprocessing (high tensile residual stress in fibers) as depicted in figure 6.19. Apparently, overprocessing degraded the fiber coating (fig. 6.20) and weakened or disrupted the interface.
